## **Fort Myers Beach Management & Planning Session**

**Thursday, February 4, 2021**

This Technical Memorandum presents the history of Estero Island Beach nourishment and results of CEC's project performance analysis, and presents the design criteria for the next renourishment project. Included herein are Project details to support the Town's Fiscal Year (FY) 2020-21 Beach and Shoreline Funding Request to the Lee County Visitor and Convention Bureau for design and permitting costs.

## Estero Island Coastal Management Plan

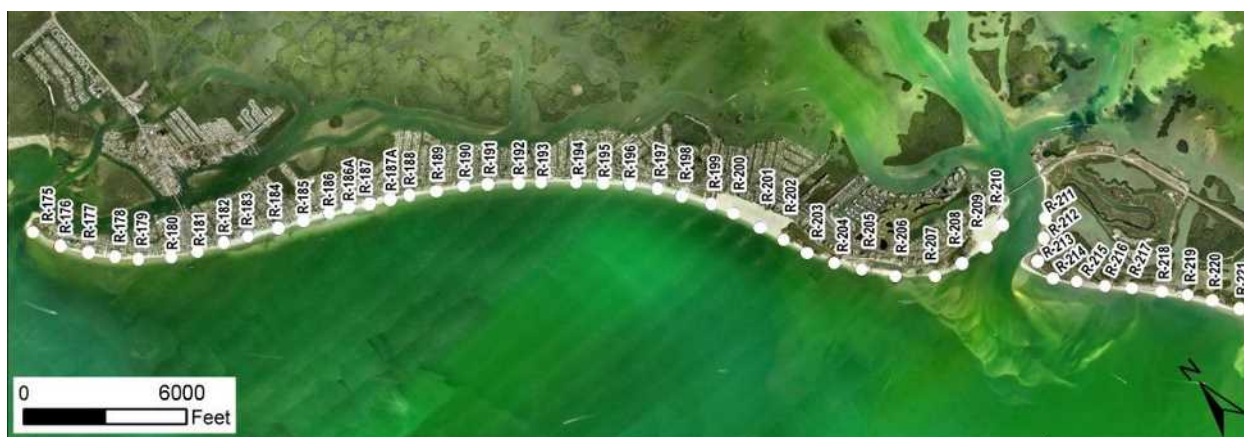
**Figure 2. Estero Island and location of R-monuments.**

An aerial photo of the project area is shown in Figure 1. Figure 2 shows Estero Island and Lover's Key along with the layout of R-monuments in the region, which are frequently used as reference points in discussion below.

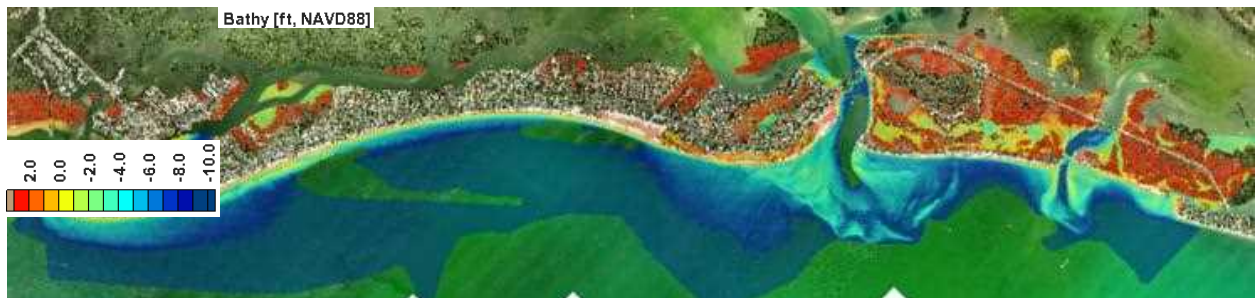
**Figure 4. Bathymetric and topographic surface of project vicinity from 2010 LIDAR data set.**

Bathymetric data is available in the form of navigation charts and through the NOAA National Ocean Service's GEODAS data clearinghouse (NOAA, 2013a). Comprehensive coverage is available and shown in Figure 3, but the data is typically old and not adequate for use in hydrodynamic modeling in inlets and along active shorelines due to their dynamic nature. In addition, 2010 LIDAR data is available for the project vicinity, shown in Figure 4 (USACE 2010). The LIDAR data provides a surface model of the subaerial land and to a limited depth by the subaqueous bottom. However, the LIDAR data has gaps, and is typically accurate to  $\pm 30$  cm (NOAA, 2013b).

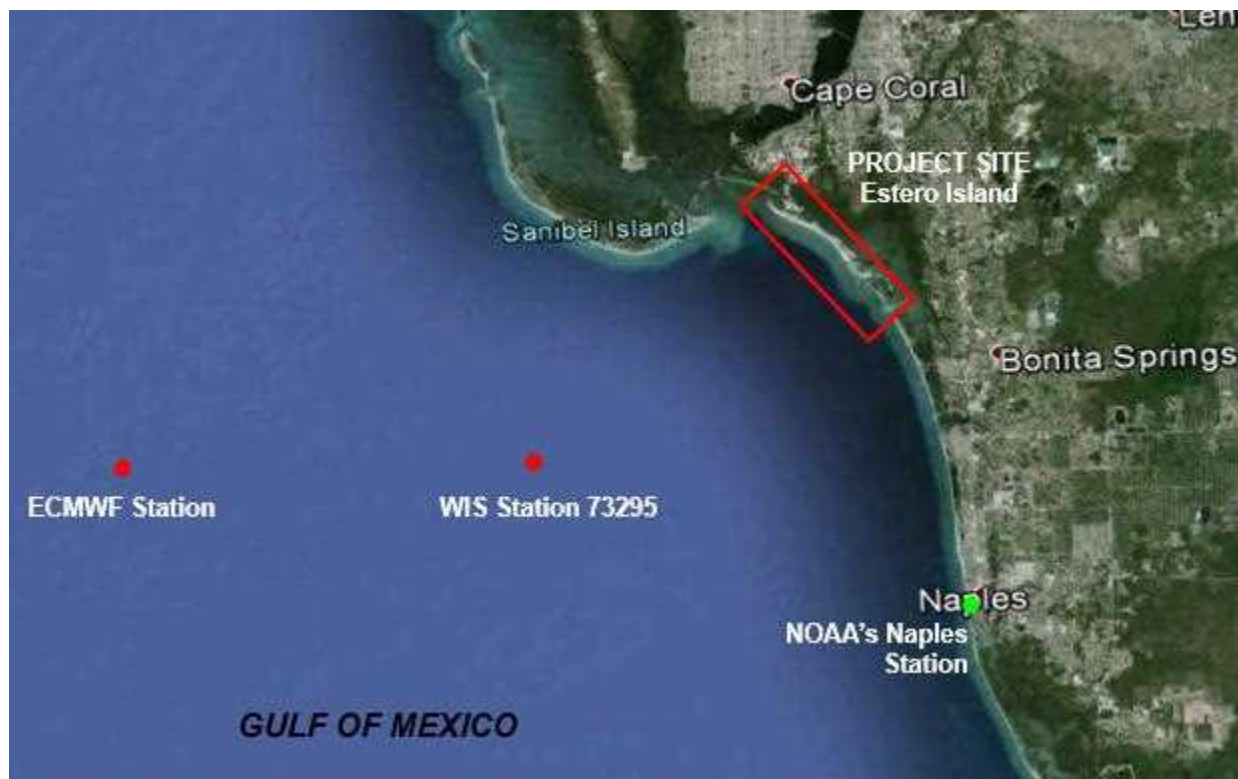
Figure 7. Data Stations used in the coastal processes analysis near Estero Island.

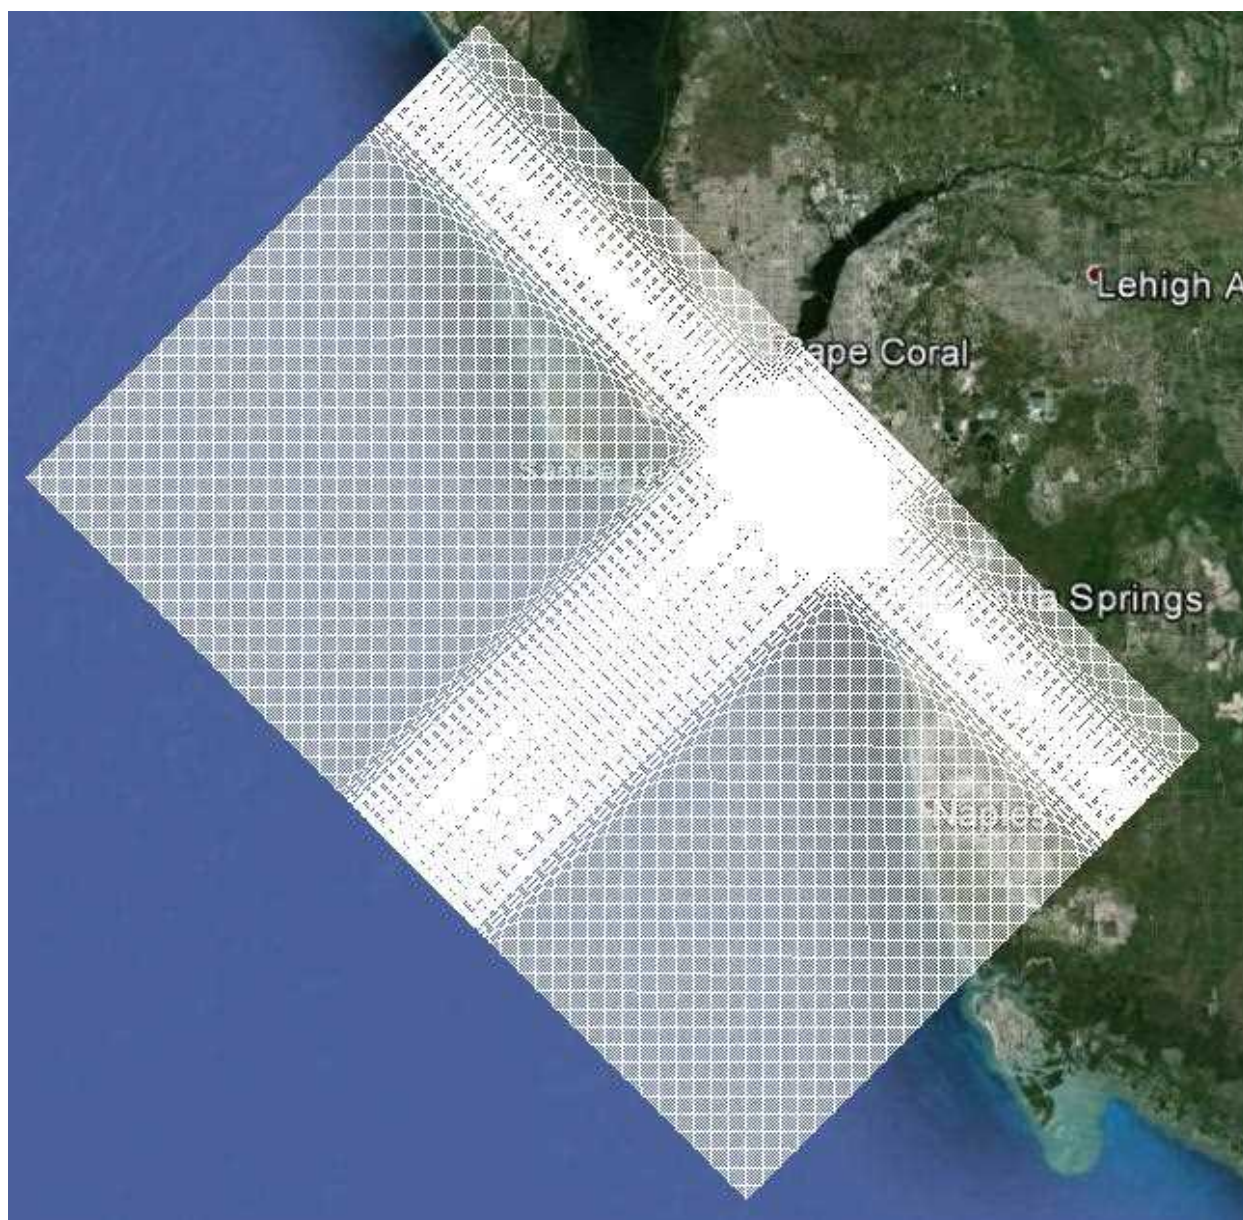
**Figure 17. EI wave model domain and variable resolution grid.**

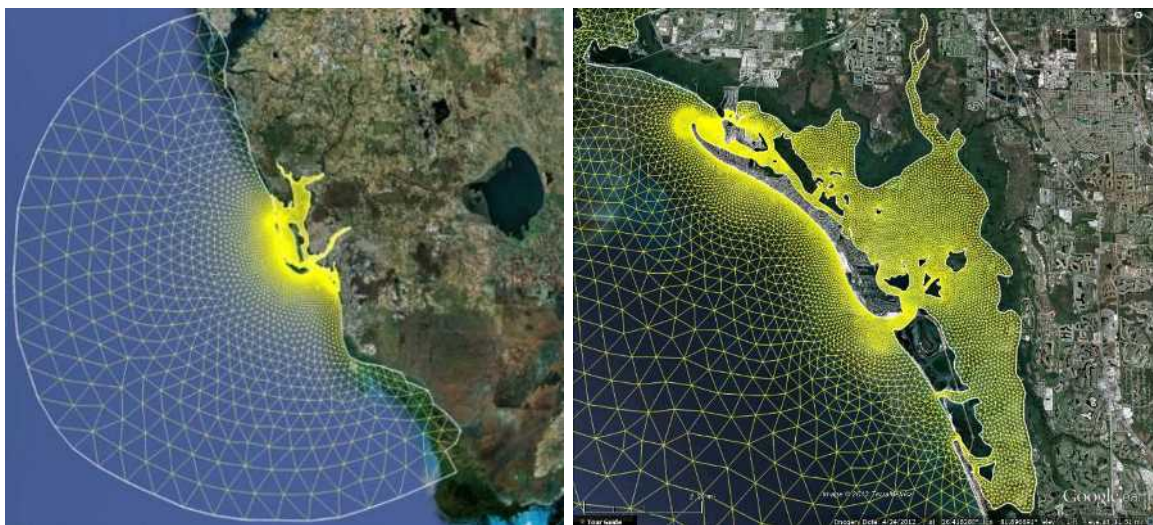
**Figure 20. El circulation model domain – entire grid (left) and El project area (right).**

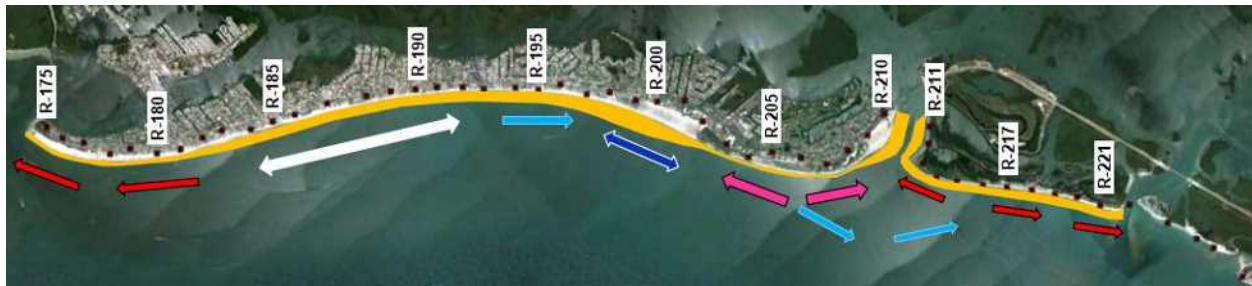
**Figure 29. Estero Island morphology patterns.**

Based on the results of the morphology analysis discussed in Section 5 and these longshore transport rates, a hypothesis on the long-term morphology patterns along the island was developed and is presented in Figure 29. This figure shows the expected transport direction by arrows, and relative magnitude by color, where cool colors show less transport and warm colors reflect more transport. The general trend is northerly transport on the north, a divergent node that occurs in the north 1/3 of the island and any given year can vary in location as much as almost two miles. Similarly, a convergent node exists between a range of R-198 and R-202. Sediment is transported into and across Big Carlos Pass and bypassed to Lovers Key. On the extreme northern end of Lover's Key, sediment is transported into the pass, and near R-215 another divergent node occurs. From R-215, transport is generally to the south along Lover's Key.

The southernmost section of the Estero Island's shoreline from R-202 to R-209 experiences large shoreline retreat varying from 50 to almost 350 ft in 8 years. After approximately 4 years, the shoreline has receded to the existing vegetation and infrastructure at R-204. The adjacent shoreline on Lover's Key also suffers mild shoreline retreat on the order of about 100 ft in 8 years. These trends correspond well to the morphological trends presented in Figure 29 in Section 6.4.

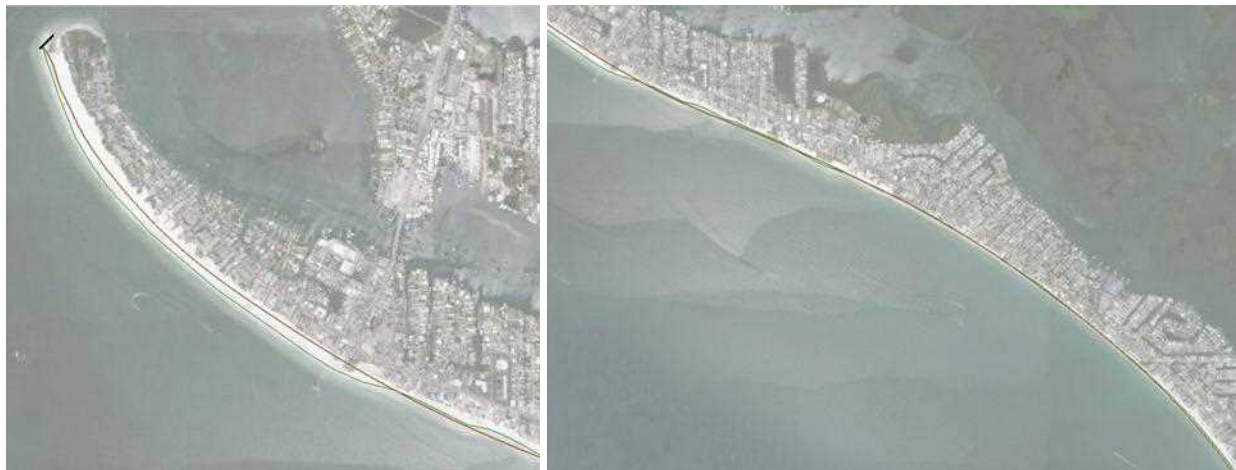
**Figure 34. Beach response for FWOP conditions for (a) Reach 1 and (b) Reach 2 shoreline after 8 years.**

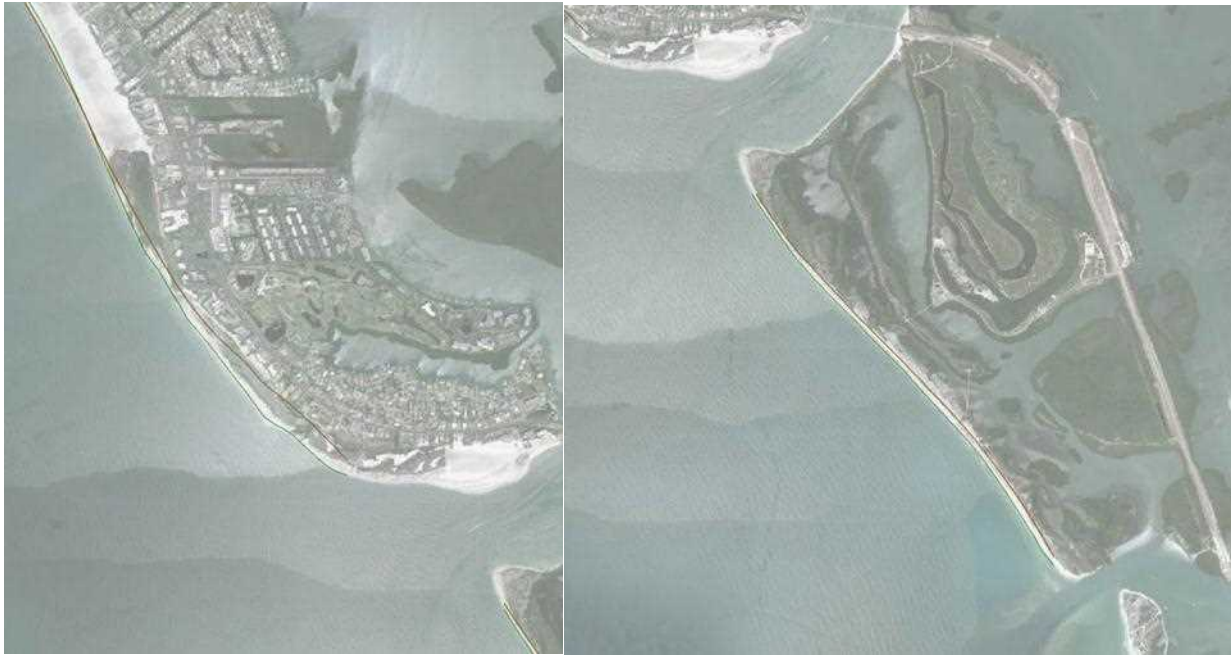
**Figure 35. Beach response for FWOP conditions for (a) Reach 3 and (b) Lover's Key shoreline after 8 years**

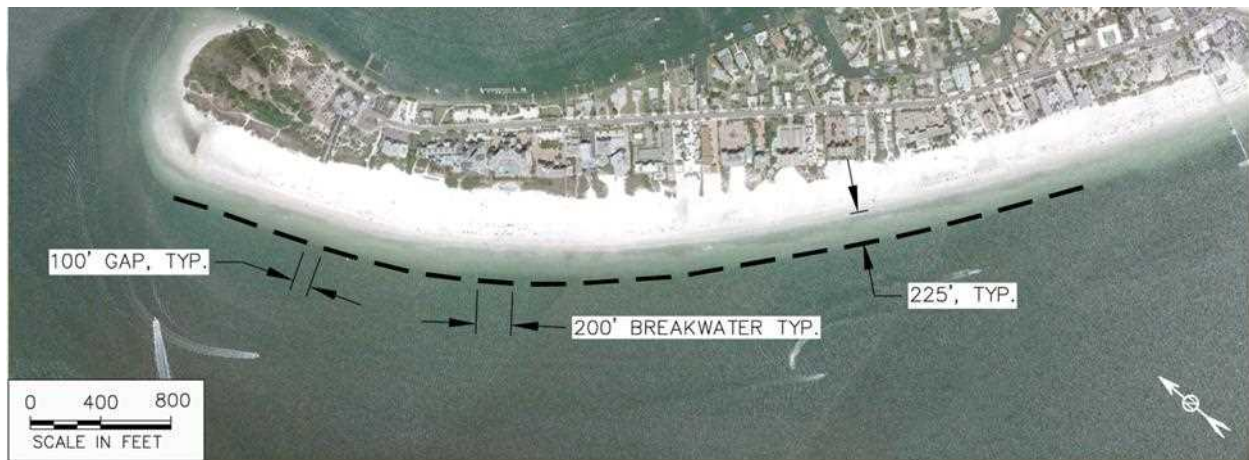
**Figure 43. Planform of breakwater alternative in Reach 1 (Alternative 1.3).**

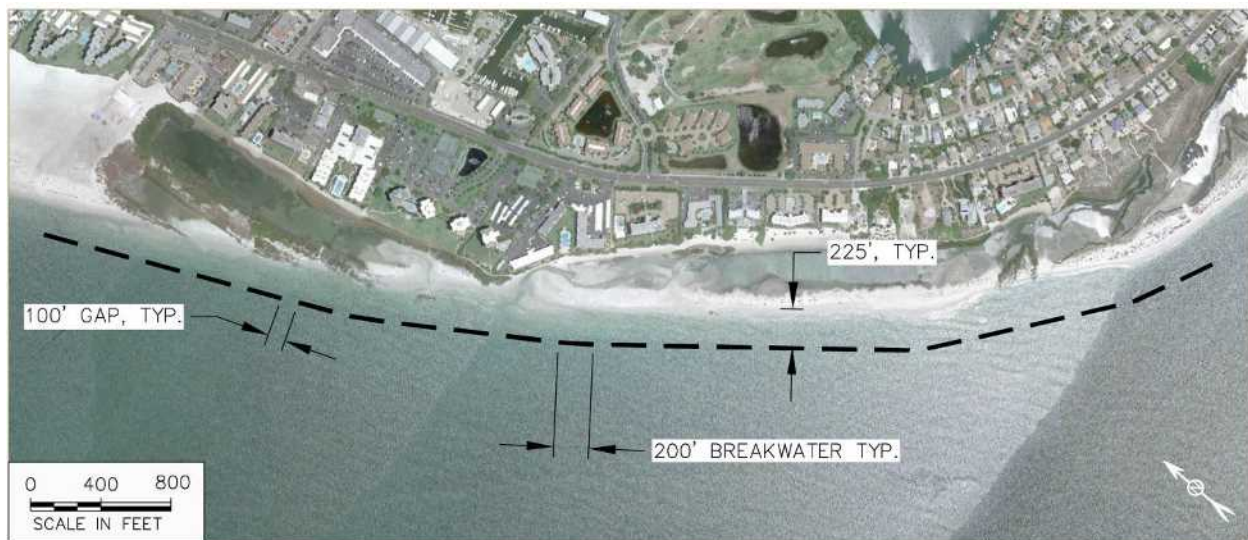
**Figure 44. Planform of breakwater alternative in Reach 3 (Alternative 3.1).**

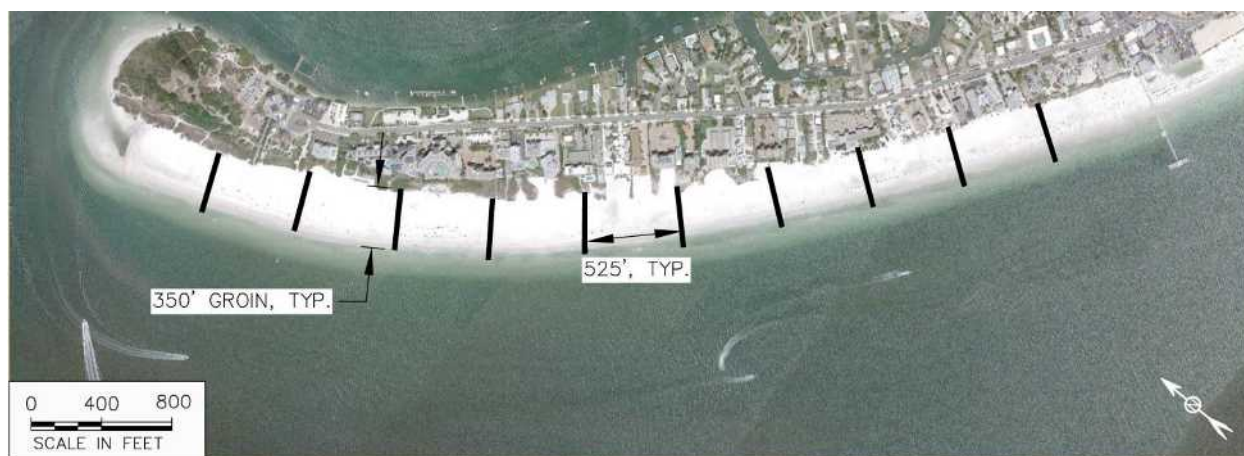
**Figure 47. Planform of short groin alternative in Reach 1 (Alternative 1.2a).**

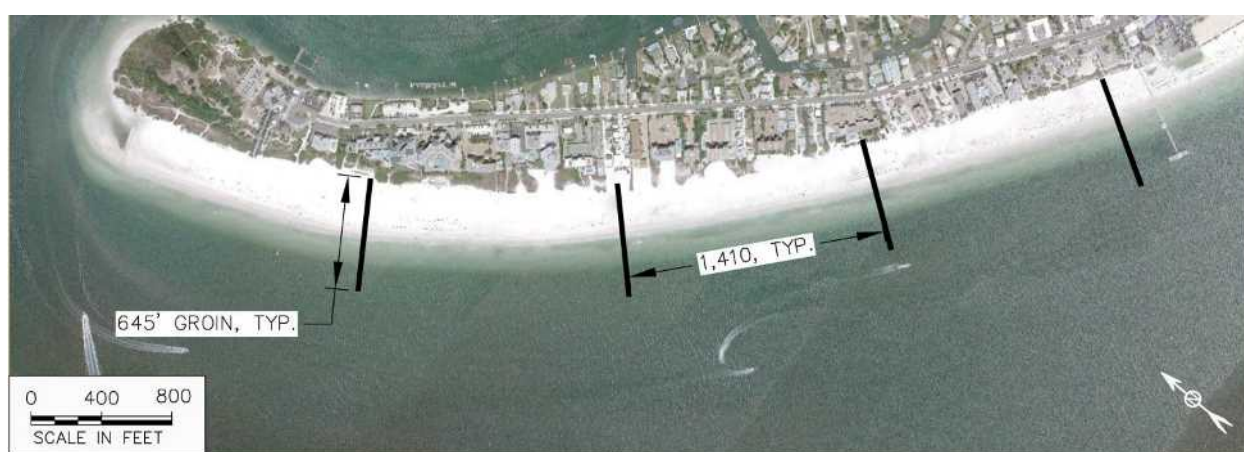
**Figure 48. Planform of long groin alternative in Reach 1 (Alternative 1.2b).**

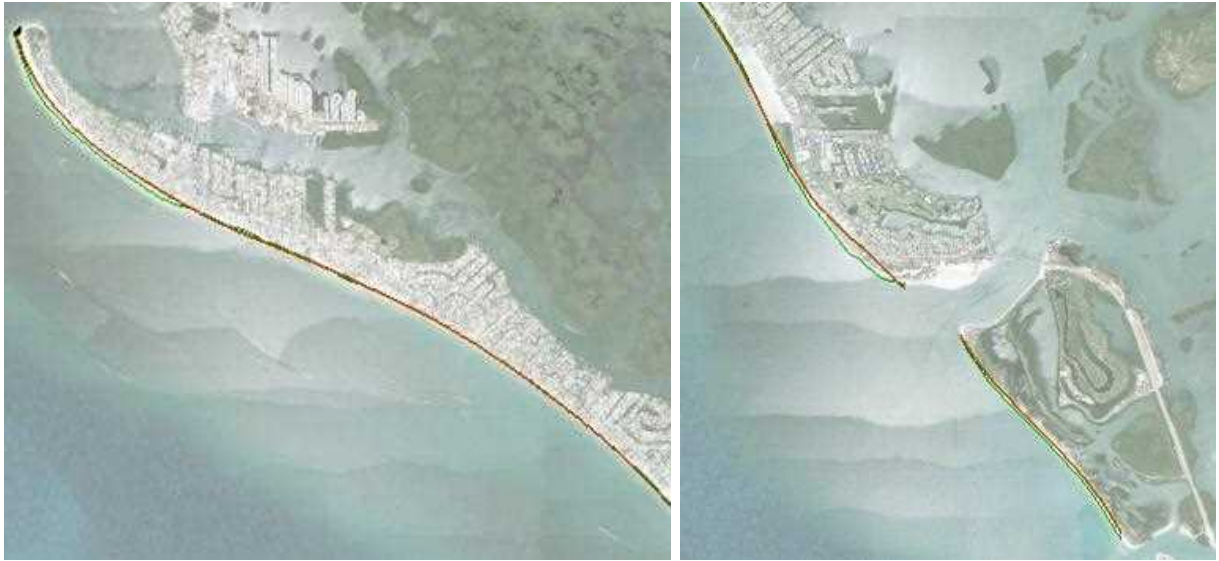
**Figure 54. Beach response for FWOP conditions for the whole project shoreline after 8 years. Green line represents the shoreline at year 0, and the brown line is the shoreline at year 8.**

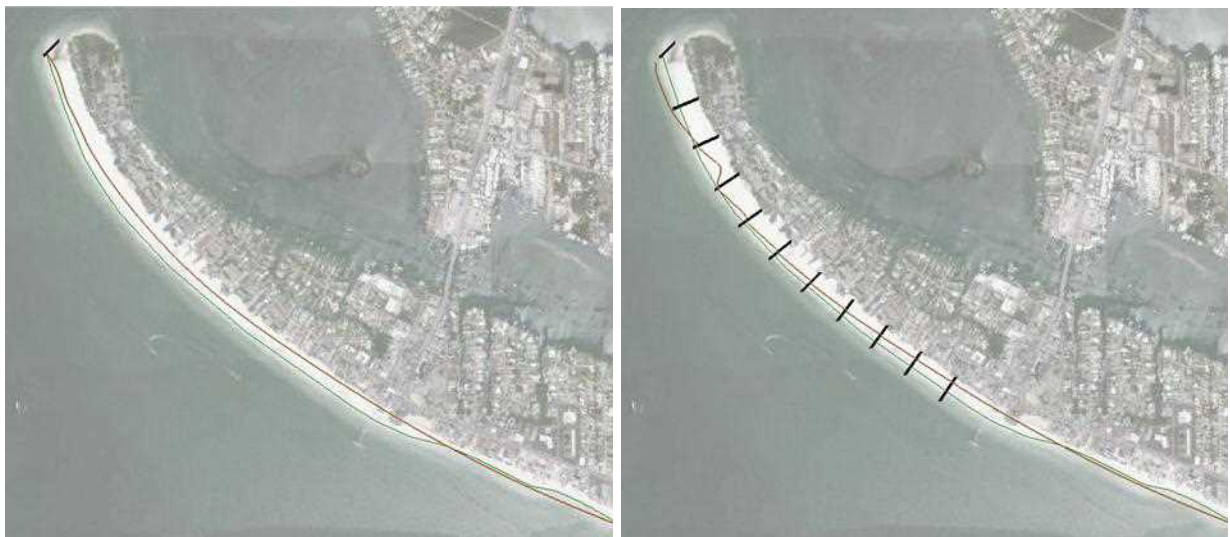
**Figure 56. Beach response for Reach 1 for (left) FWOP conditions and (right) Alt 1.2 after 8 years. Green line represents the shoreline at year 0, and the brown line is the shoreline at year 8.**

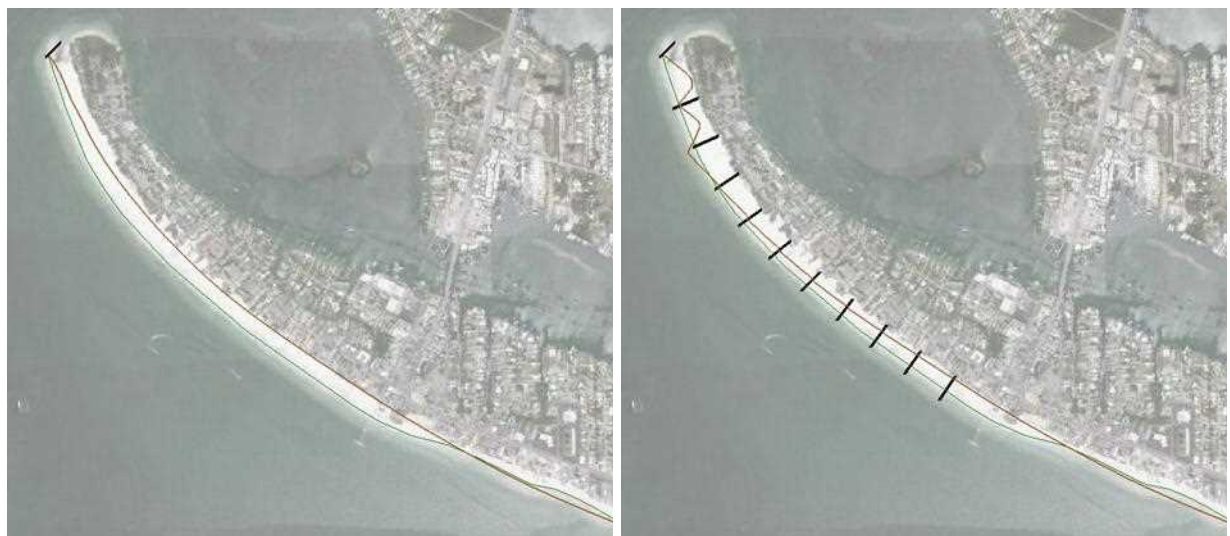
**Figure 57. Beach response for Reach 1 for (left) FWOP conditions and (right) Alt 1.2 after 14 years. Green line represents the shoreline at year 0, and the brown line is the shoreline at year 14.**

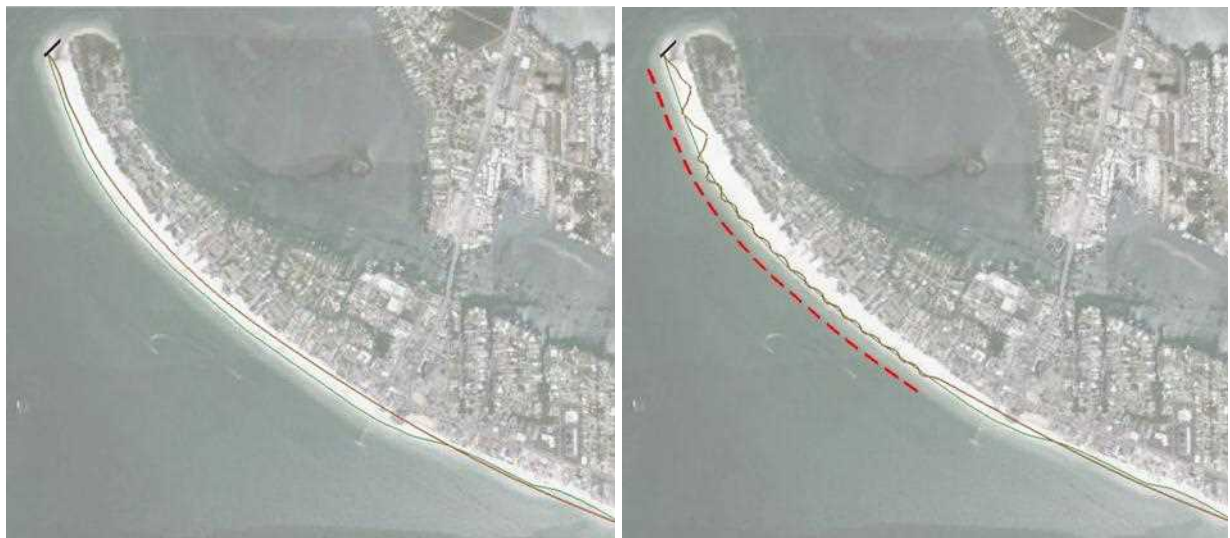
**Figure 60. Beach response for Reach 1 for (left) FWOP conditions and (right) Alt 1.3 after 8 years. Green line represents the shoreline at year 0, and the brown line is the shoreline at year 8.**

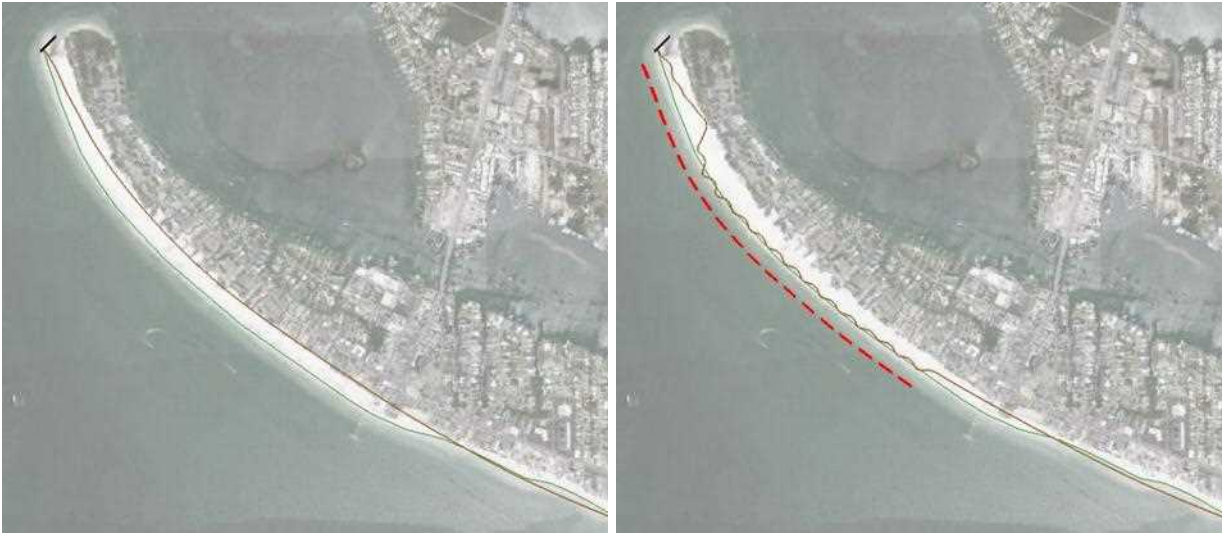
Figure 61. Beach response for Reach 1 for (left) FWOP conditions and (right) Alt 1.3 after 15 years. Green line represents the shoreline at year 0, and the brown line is the shoreline at year 15.

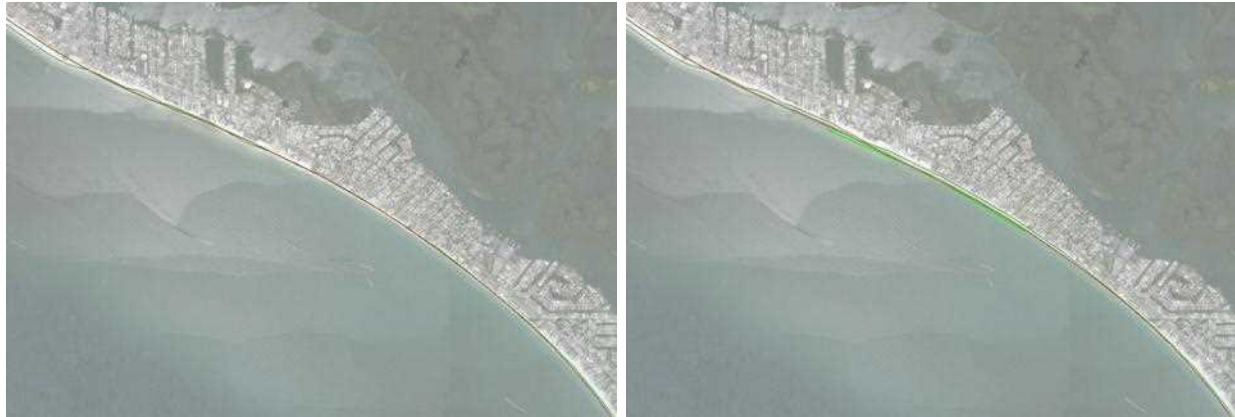
**Figure 64. Beach response for Reach 2 for (left) FWOP conditions and (right) Alt 2.1 after 8 years. Green line represents the shoreline at year 0, and the brown line is the shoreline at year 8.**

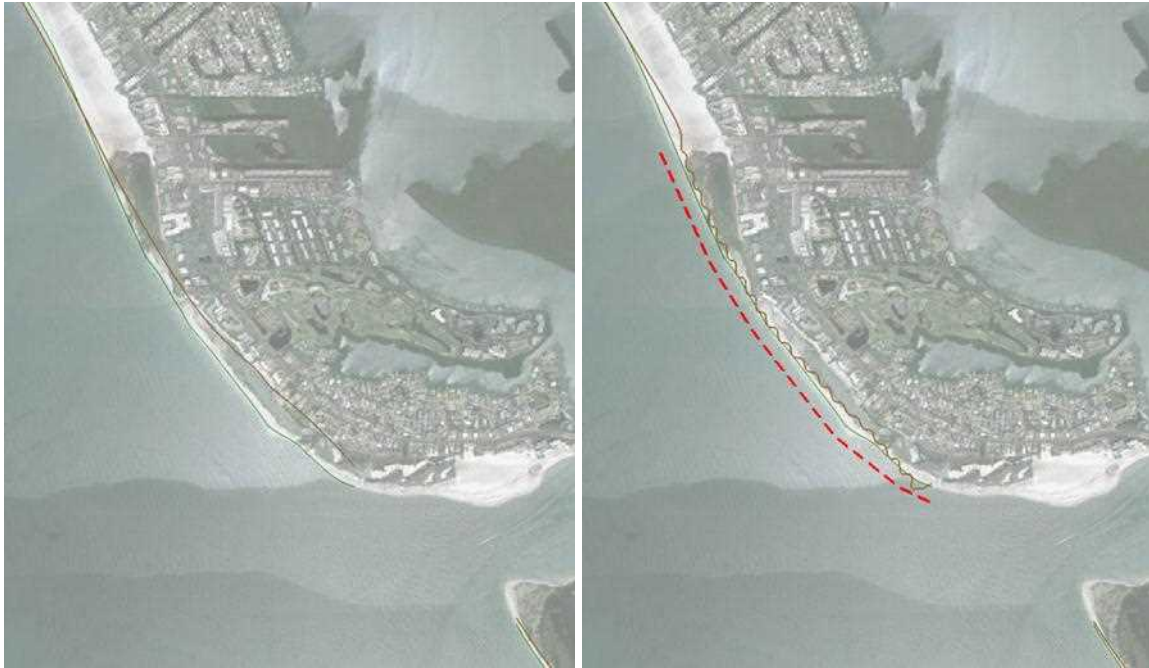
Figure 67. Beach response for Reach 3 for (left) FWOP conditions and (right) Alt 3.1 after 12 years. Green line represents the shoreline at year 0, and the brown line is the shoreline at year 12.

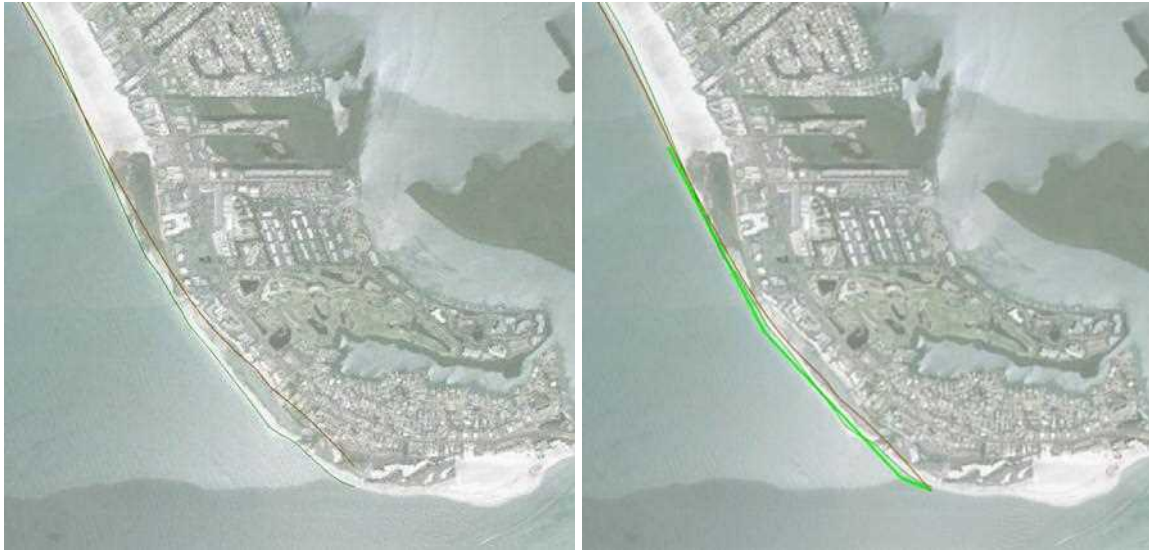
**Figure 69. Beach response for Reach 3 for (left) FWOP conditions and (right) Alt 3-2 after 12 years. Green line represents the shoreline at year 0, and the brown line is the shoreline at year 12.**

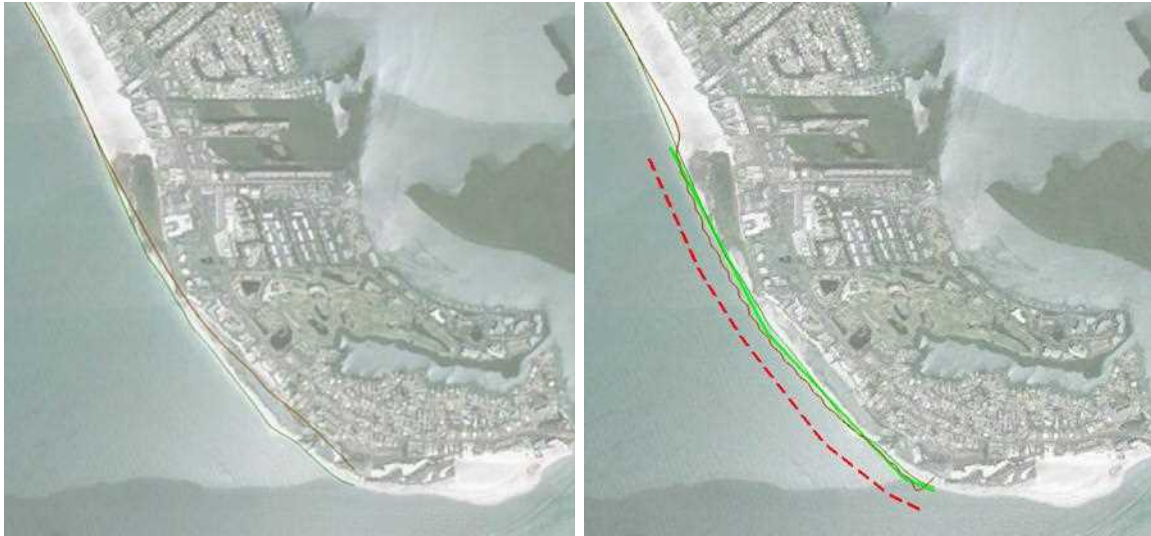
**Figure 71. Beach response for Reach 3 for (left) FWOP conditions and (right) Alt 3.3 after 8 years. Green line represents the shoreline at year 0, and the brown line is the shoreline at year 8.**

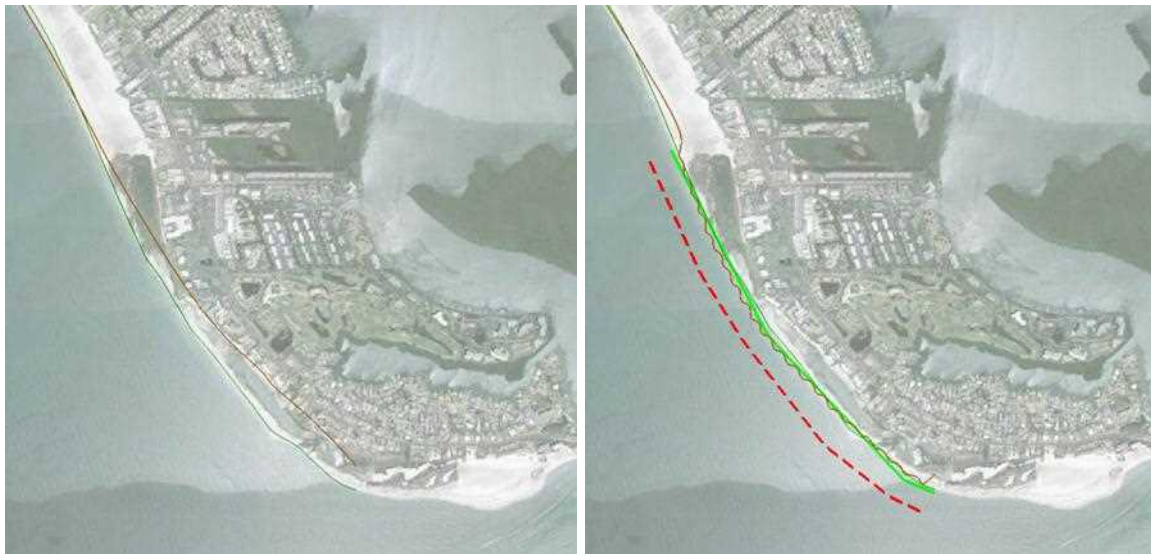
**Figure 72. Beach response for Reach 3 for (left) FWOP conditions and (right) Alt 3.3 after 15 years. Green line represents the shoreline at year 0, and the brown line is the shoreline at year 15.**
